**PRELIMINARY ASSESSMENT/  
VISUAL SITE INSPECTION**

**TITANIUM METALS CORPORATION OF AMERICA  
TORONTO, OHIO  
OHD 098 435 134**

**FINAL REPORT**

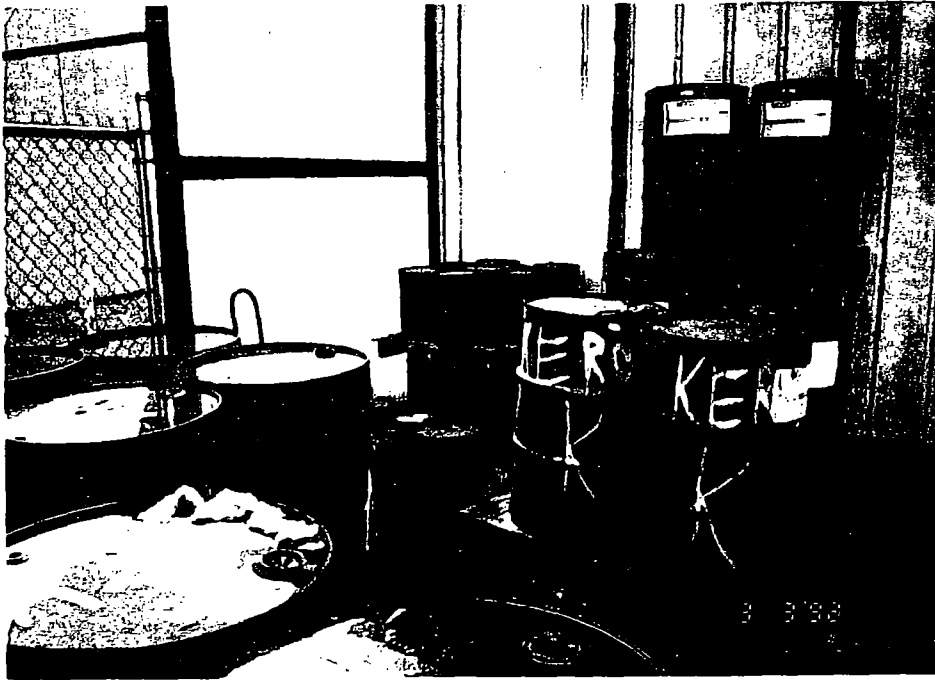
Location: SWMU 1  
 Date: 03/03/92

Photograph No. 1  
 Orientation: Southeast  
 Description: Drum storage area 1

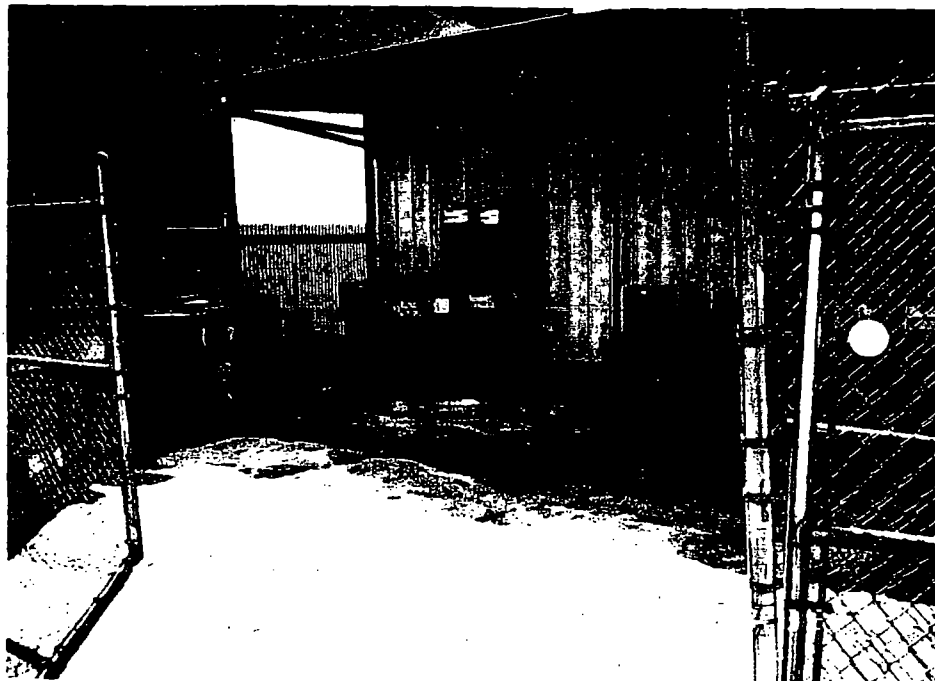
Location: SWMU 1  
 Date: 03/03/92

Photograph No. 2  
 Orientation: Southeast  
 Description: Drum storage area 1 (notice fence around the perimeter)

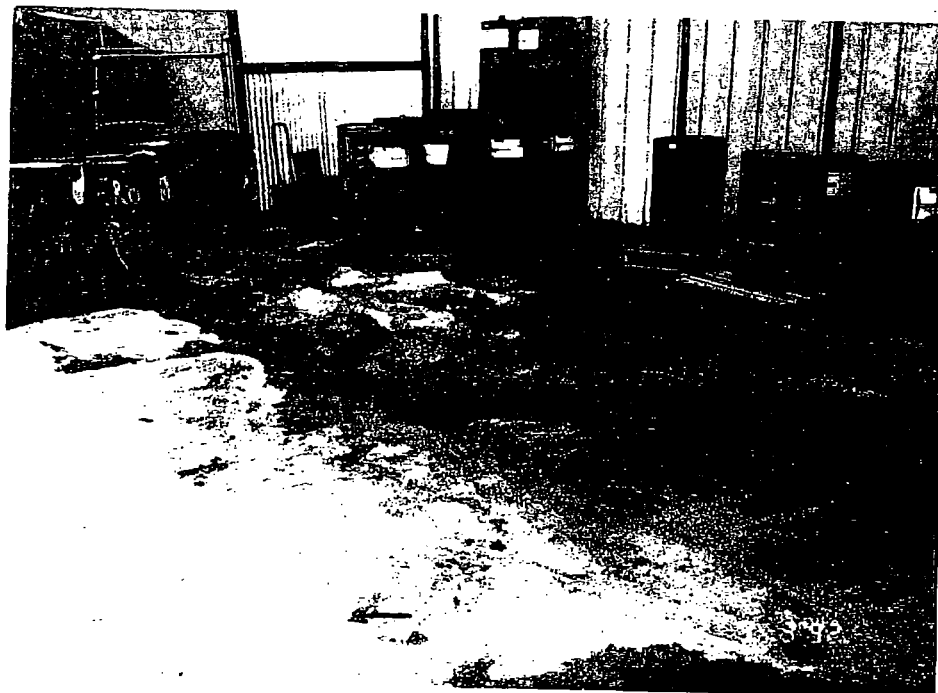
**Photograph No.** 3

**Observations:** Most of the drums in this unit were in poor condition. Many of the drums showed signs of excessive wear and rusting. During the site inspection, there appeared to be saturated absorbent material on the floor of the unit. It is unknown whether the saturated material contained hazardous or nonhazardous constituents. PRC observed no cracks on the floor surface, although visibility of the floor surface was obscured by the absorbent.

PRC recommends that the facility construct diking around the unit to serve as containment of potentially spilled material. PRC also recommends labeling all drums and removing drums in poor condition.

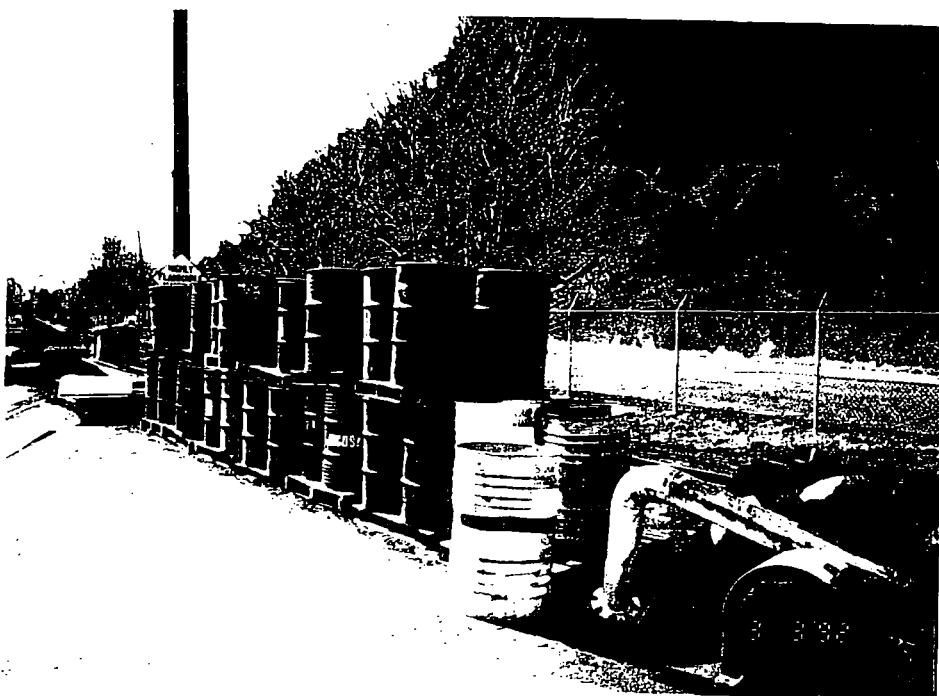
**Photograph No.** 4

**Observations:** The unit contained approximately twenty 55-gallon drums of waste oil, approximately 6 steel bins of swarf, approximately forty 55-gallon drums of titanium swarf, and numerous 55-gallon drums full of scrap titanium and other metals. In addition, there was titanium scrap stored in wooden crates adjacent to the unit; the scrap is shipped back to Nevada and melted back into ingots or sold to scrap dealers (Turic, 1992b). Evidence of release was noted. Although the steel bins appeared to be in good condition, there was spilled swarf surrounding the storage area. Many of the drums showed signs of excessive wear and rusting. At least one drum was open and had a brown oily substance seeping down the sides of the container.

PRC recommends that the facility pave the entire area or store waste only in areas that are paved. In addition, the facility should construct diking around the paved portions of the unit to prevent potentially spilled material from migrating to exposed soils adjacent to the unit. PRC also recommends consolidating wastes and storing them in a specific area that is paved. The facility should also label all drums and remove drums in poor condition.

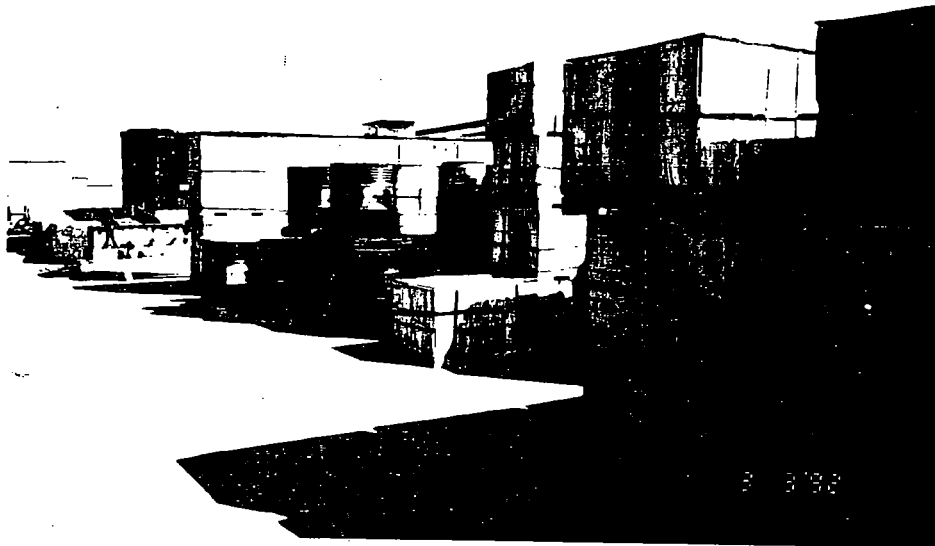
**Location:** SWMU 2  
**Date:** 03/03/92

**Photograph No.** 5  
**Orientation:** Northeast  
**Description:** Drum storage area 2 (wooden crates of scrap titanium)

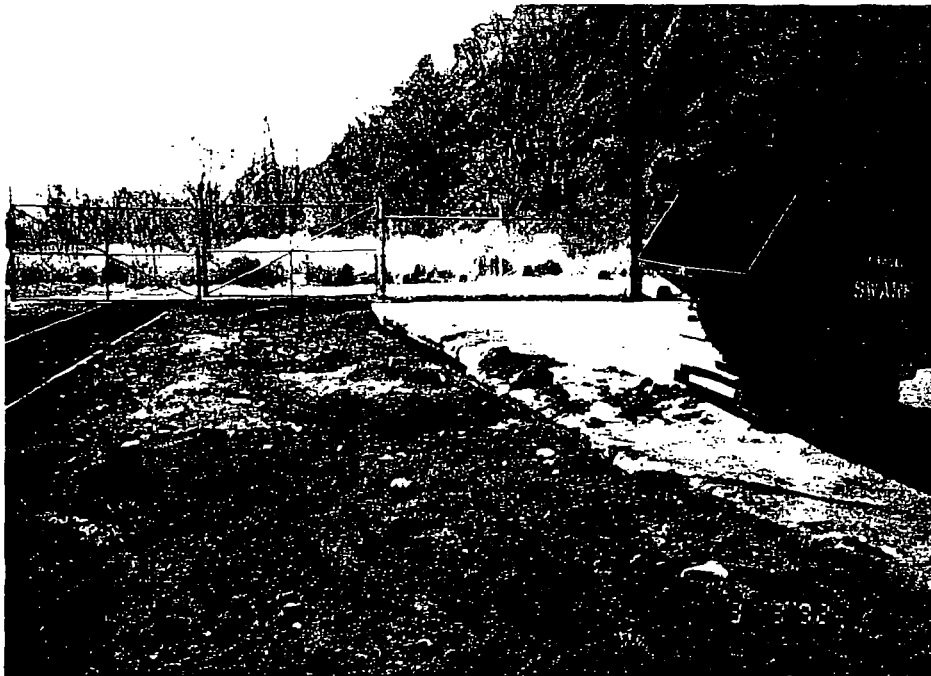
**Location:** SWMU 2  
**Date:** 03/03/92

**History of Release:** Moderate amounts of spilled titanium swarf were observed on the asphalt and exposed soil during the site inspection (see Photograph No. 7). In addition, some drums were missing lids and had a brown oily substance seeping down the sides of the container (see Photograph No. 8).

On-Site Soils: High. During the site inspection, moderate amounts of spilled swarf were noted on exposed soils.

**Photograph No.** 7  
**Orientation:** South  
**Description:** Drum storage area 2 (spilled swarf)

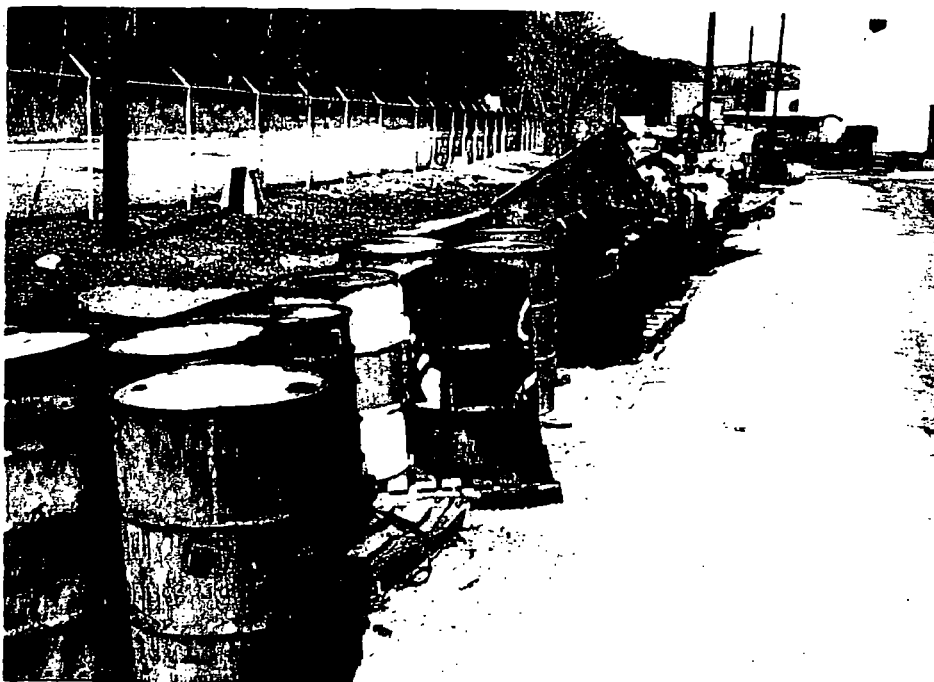
**Location:** SWMU 2  
**Date:** 03/03/92

In addition to drum storage areas 1 and 2 (SWMUs 1 and 2), there were numerous stray drums stored in other areas of the facility property (see Photograph No. 8). Most of the drums were elevated on wooden pallets; the areas were not designated as specific drum storage areas and had no release controls. In addition, several drums were in poor condition, with signs of excessive wear and rusting. At least one drum was open and had a brown oily substance seeping down the sides of the container. This unit was identified as an AOC because of the random storage practices, lack of release controls, and poor conditions of the drums. It is unknown what was contained within the drums.

**Photograph No.** 8  
**Orientation:** Northwest  
**Description:** Drum storage area 2 (notice brown substance seeping down the sides of the drum)

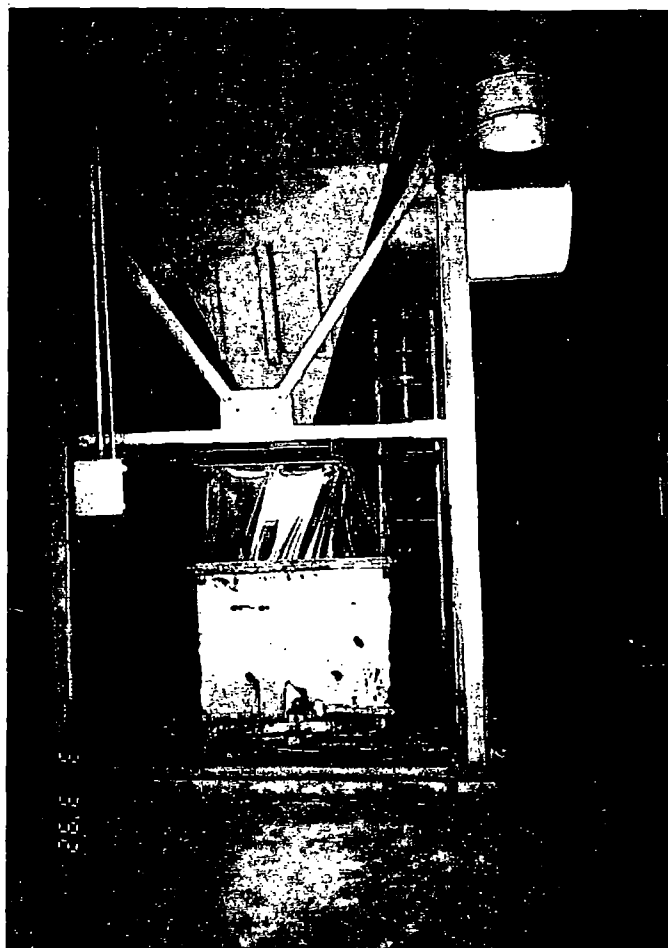
**Location:** SWMU 3  
**Date:** 03/03/92

**Unit Description:** These units collect and store the dust generated by the sandblasting and shotblasting of titanium. There are nine baghouses located inside in the northern portion of the forge shop (see Photograph No. 9). Four baghouses are located outdoors on the north end of the bar finishing building (see Photograph No. 10). The units are made of steel and are tapered to a funnel shape at the bottom. Steel hoppers (approximately 20 cubic feet) are situated on the pavement below each baghouse and are used to collect and transport the dust for disposal. No floor drains were noted near any of the hoppers.

**Photograph No.** 9  
**Orientation:** Southwest  
**Description:** Baghouses inside the northern portion of the forge shop

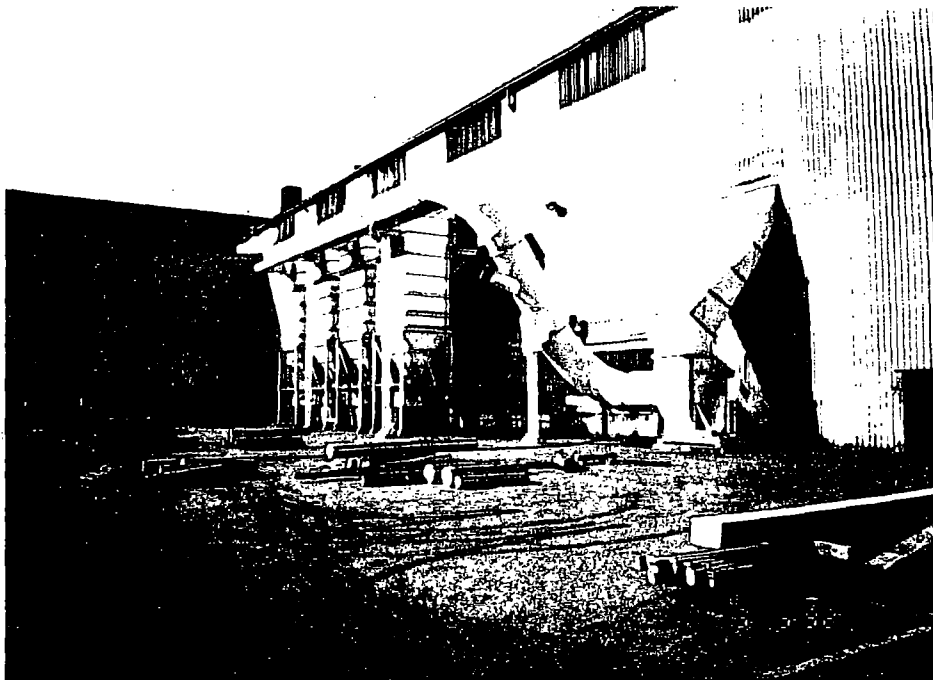
**Location:** SWMU 3  
**Date:** 03/03/92

**Photograph No.** 10  
**Orientation:** Southwest  
**Description:** Baghouses on the north end of the bar finishing building

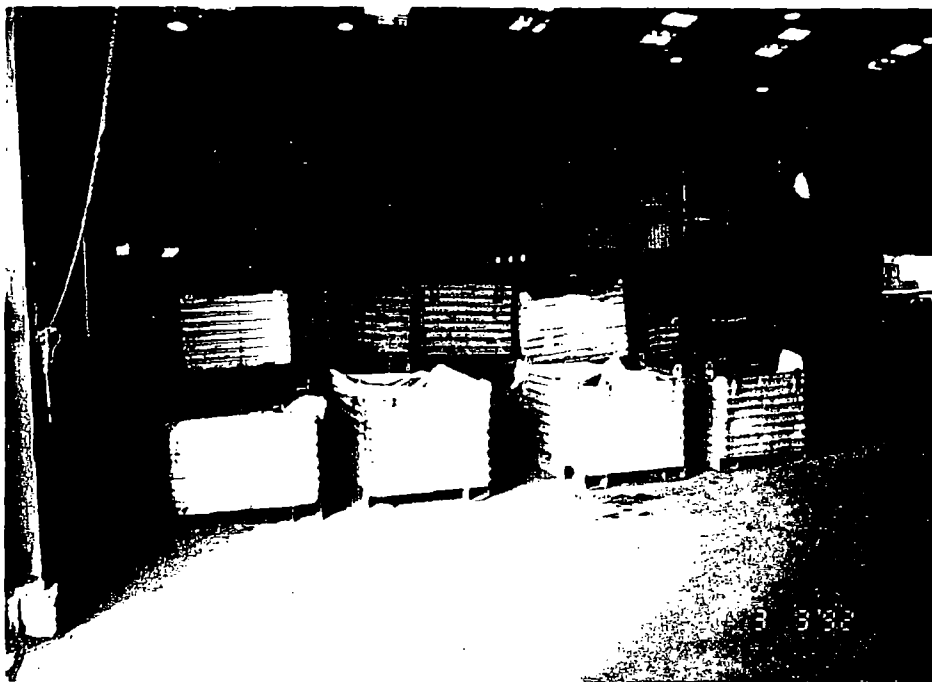
**Location:** SWMU 3  
**Date:** 03/03/92

**Observations:** The hoppers appeared to be structurally sound and well maintained. No evidence of release was noted.

**Photograph No.** 11  
**Orientation:** Northwest  
**Description:** Portable steel hoppers used to collect and transport baghouse dust

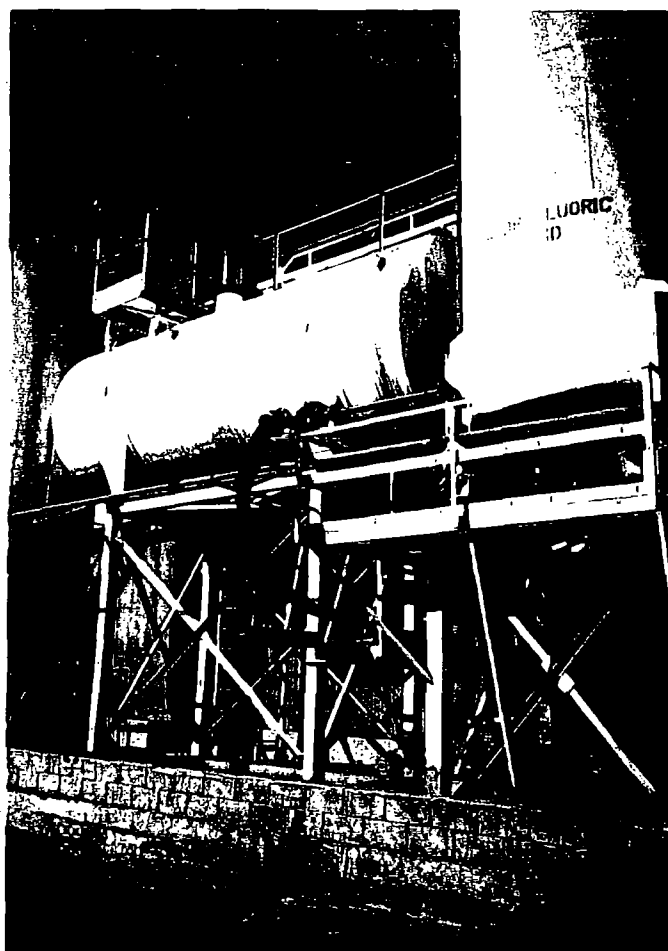
**Location:** SWMU 4  
**Date:** 03/03/92

**Observations:** Both the holding tank and the secondary containment appeared to be in good condition; however, the tank did show a small amount of rusting. No cracks were visible in the concrete secondary containment. No evidence of release was noted.

**Photograph No.** 12  
**Orientation:** Southwest  
**Description:** Spent acid storage tank 1

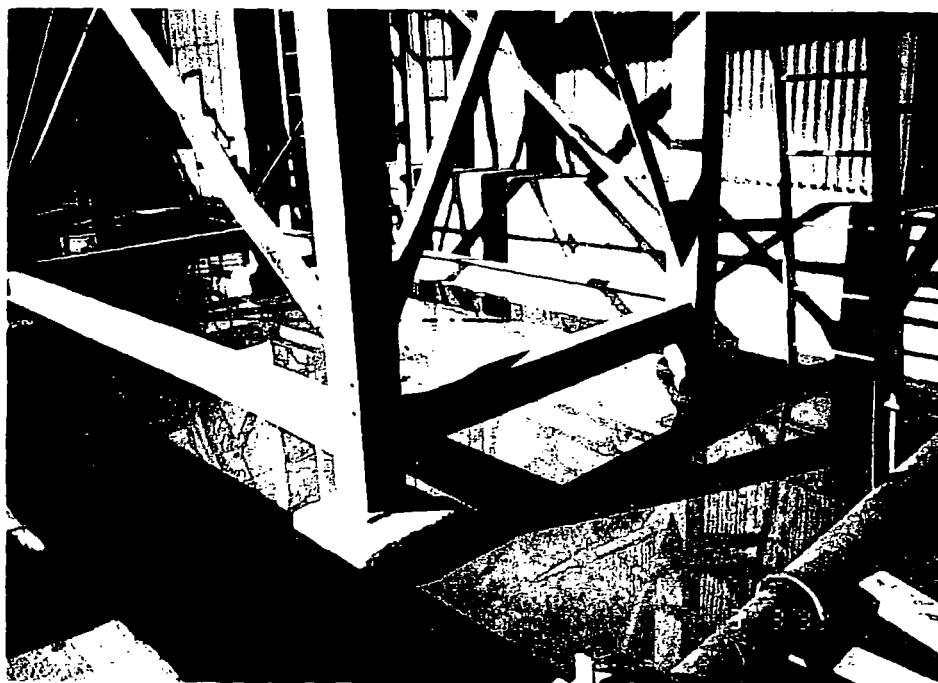
**Location:** SWMU 4  
**Date:** 03/03/92

**Release Controls:** This unit rests within a 32-inch-deep concrete pit that acts as secondary containment. The concrete floor has an acid-proof coating to prevent leaks in case of a spill. No drains were observed in the vicinity of the tank.

There are no release control measures that would contain spilled material resulting from a rupture in the tank. If such a release occurred, the material would spray over the secondary containment.

**Photograph No.** 13  
**Orientation:** Northwest  
**Description:** Secondary containment under spent acid storage tank 1

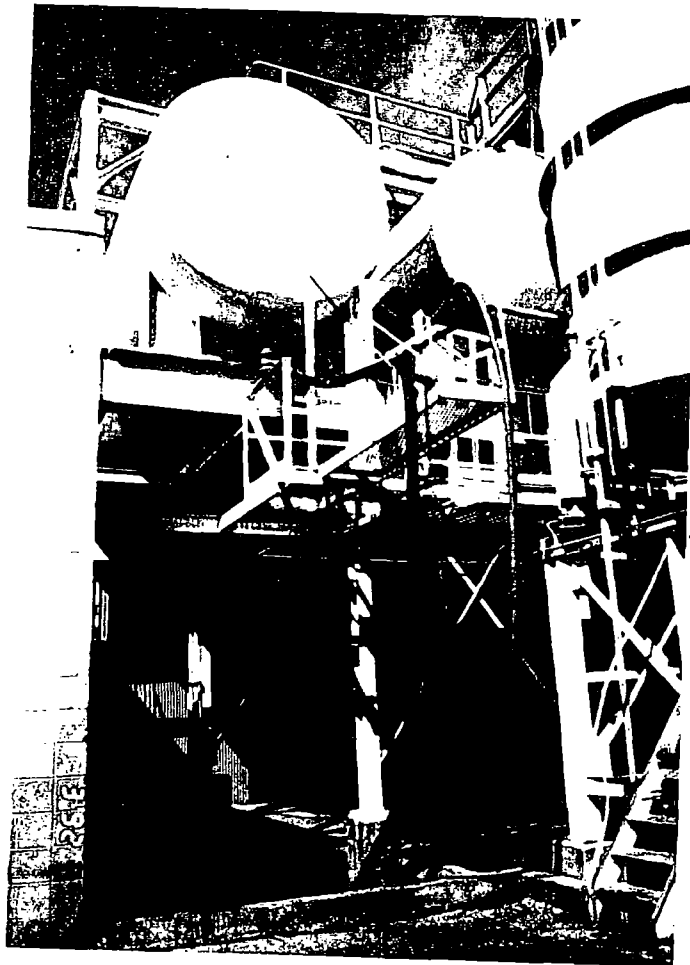
**Location:** SWMU 5  
**Date:** 03/03/92

**Observations:** Both the holding tank and the secondary containment appeared to be in good condition; however, the tank did show a small amount of rusting. No cracks were visible in the concrete secondary containment. No evidence of release was noted.

14  
Southwest  
Secondary containment under spent acid storage tank 2

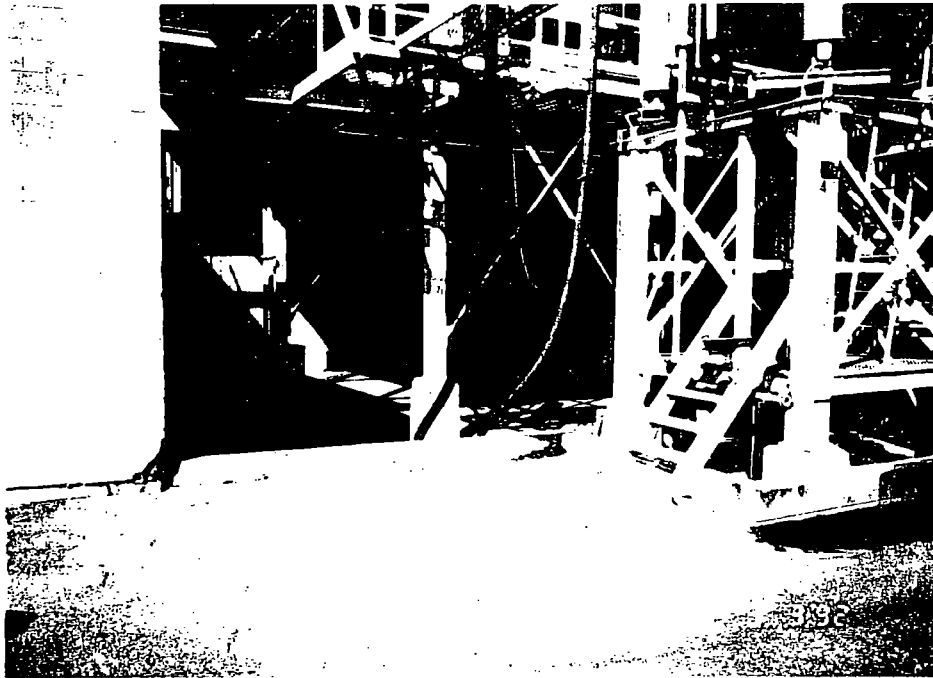
**Location:** SWMU 5  
**Date:** 03/03/92

**Release Controls:** This unit rests within a 24-inch-deep concrete pit that acts as secondary containment. The concrete floor has an acid-proof coating to prevent leaks in case of a spill. No drains were observed in the vicinity of the tank. There are no release control measures that would contain spilled material resulting from a rupture in the tank. If such a release occurred, the material would spray over the secondary containment.

**Photograph No.** 15  
**Orientation:** Northwest  
**Description:** Secondary containment under spent acid storage tank 2

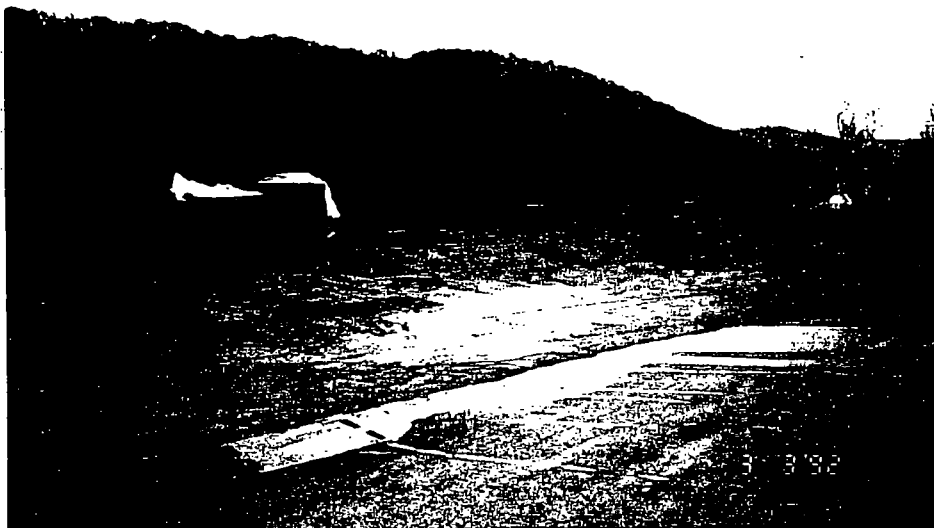
**Location:** SWMU 6  
**Date:** 03/03/92

**Unit Description:** The former drum storage area is located outdoors on the eastern portion of the property. The unit was used to store 55-gallon drums containing caustic kolene sludge, which was generated from a former pickling process. The unit was a paved area approximately 50 feet wide by 20 feet long. The unit reportedly was capable of storing approximately 80 drums. A drain that leads to outfall No. 006 and eventually discharges to the Ohio River was observed near the former storage area (see Photograph No. 16) (Turic, 1992b).

**Observations:** This unit was vacant during the inspection. The facility representative identified the approximate location of the former storage area. Small cracks in the asphalt were observed as well as a large drain near the former drum storage area. The drain leads to NPDES outfall No. 006 and discharges to the Ohio River. No evidence of release was noted.

**Photograph No.** 16  
**Orientation:** Southeast  
**Description:** Approximate location of the former drum storage area  
 (notice drain in left corner of the frame)

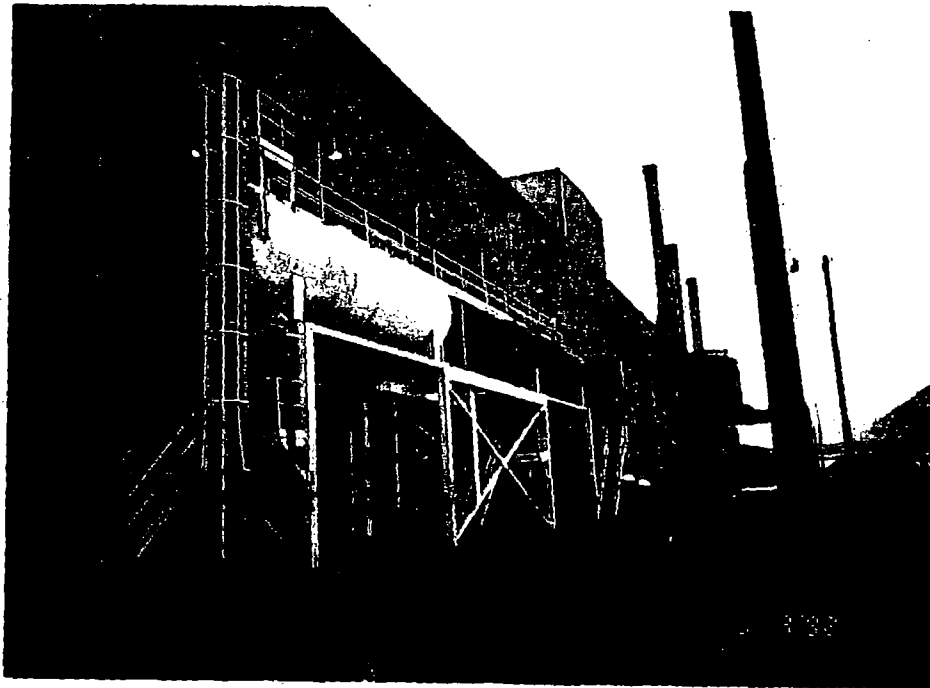
**Location:** SWMU 7  
**Date:** 03/03/92

**Observations:** The unit was inactive and the holding tank was reported to be empty. The holding tank and the secondary containment appeared to be in good condition; however, the tank did show a small amount of rusting. No cracks were visible in the secondary containment. No evidence of release was noted.

**Photograph No.** 17  
**Orientation:** Southeast  
**Description:** Former spent acid storage tank 1
